# Detection of hydrogen in high strength steel with an N-15 nuclear resonance.

*Presented by : Jean-Simon Laroche*

*Université de Montréal, CRIAQ project (DPHM-601)*

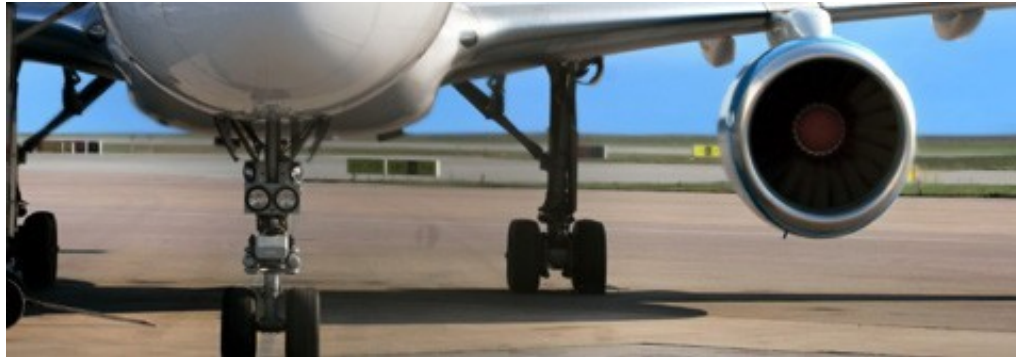
## Hydrogen Embrittlement

Hydrogen in steel decreases its mechanical strength dramatically.

To protect steel pieces, they use protective coating.

The coating can also introduce hydrogen.
